# Stream Inventory Report

## Nolan Creek

Salmon Creek Watershed  
Sonoma County, California

Survey: Summer 2003  
Final Report: September, 2004  
Revised May 2007

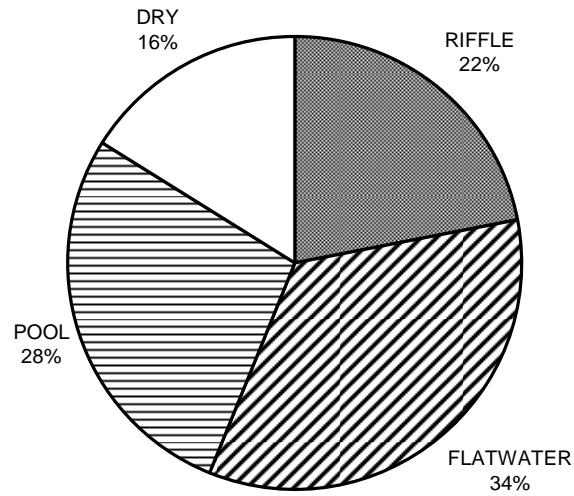
GRAPH 1. Level II habitat types by percent occurrence.

Table 1 summarizes the Level II riffle, flatwater, and pool habitat types. Based on frequency of *occurrence* there were 33.6% Flatwater units, 28.4% Pool units, 22.0% Riffle units and 15.9% Dry units (Graph 1). Based on total *length* there were 40.3% Flatwater units, 22.5% Pool units, 18.8% Dry units and 18.4% Riffle units (Graph 2).

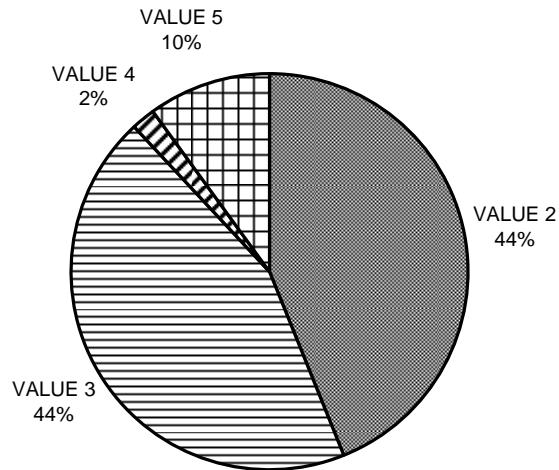
GRAPH 6. Percent embeddedness estimated at pool tail-outs.

The depth of cobble embeddedness was estimated at pool tail-outs. Of the 66 pool tail-outs measured, 29 had a value of 2 (44%), 29 had a value of 3 (44%) and 1 had a value of 4 (2%) (Graph 6). Seven (11%) riffles rated a 5 (unsuitable substrate type for spawning). On this scale, a value of one is best for fisheries. Gravel was the dominant substrate observed at pool tail-outs (Graph 8). No mechanical gravel sampling was conducted in 2003 surveys due to inadequate staffing levels.

Forty-five percent of the pool tail-outs measured had embeddedness ratings of either 3 or 4. None had a rating of 1. Cobble embeddedness measured to be 25% or less (a rating of 1) is considered best for the needs of salmon and steelhead. In a reach comparison, Reaches 2 and 3 had the best ratings and Reaches 1 and 4 had the poorest ratings.

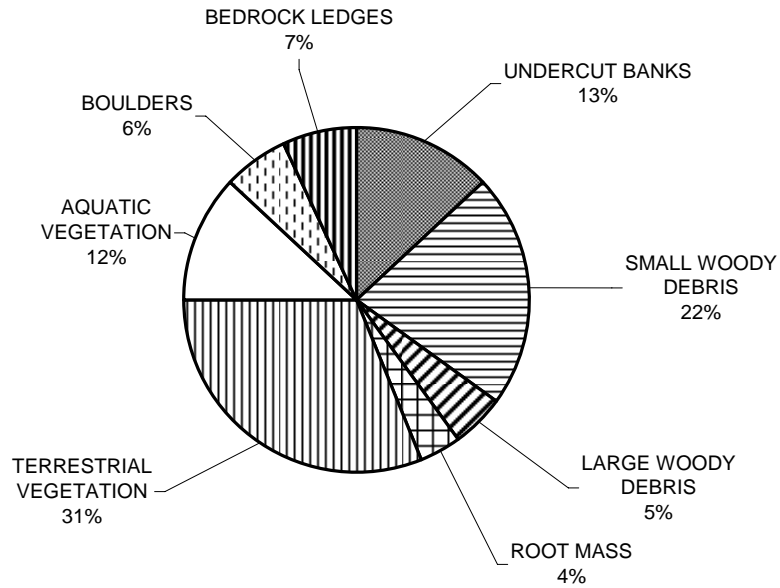
GRAPH 7. Mean percent cover types in pools.

Table 5 summarizes fish shelter by habitat type. By percent area, the dominant pool shelter types were Terrestrial Vegetation

at 31%, Small Wood at 22%, Undercut Banks at 13%, Aquatic Vegetation at 12%, Bedrock at 7%, Boulders at 6%, Large Wood at 4%, and Root Mass at 4%. Graph 7 describes the pool shelter in Nolan Creek.

The mean shelter rating for pools was 26. A pool shelter rating of approximately 80 is desirable. The relatively small amount of pool shelter that now exists is being provided primarily by Terrestrial Vegetation at 31%, Small Wood at 22%, Undercut Banks at 13%, Aquatic Vegetation at 12%, Bedrock at 7%, Boulders at 6%, Large Wood at 4%, and Root Mass at 4% and White Water at 0%. Log and root wad cover in the pool and flatwater habitats would improve both summer and winter salmonid habitat. Log cover provides rearing fry with protection from predation, rest from water velocity, and also divides territorial units to reduce density-related competition.

- 6) Where feasible, increase woody cover in the pool and flatwater habitat units along the entire stream. Most of the existing shelter is from terrestrial vegetation and small woody debris.

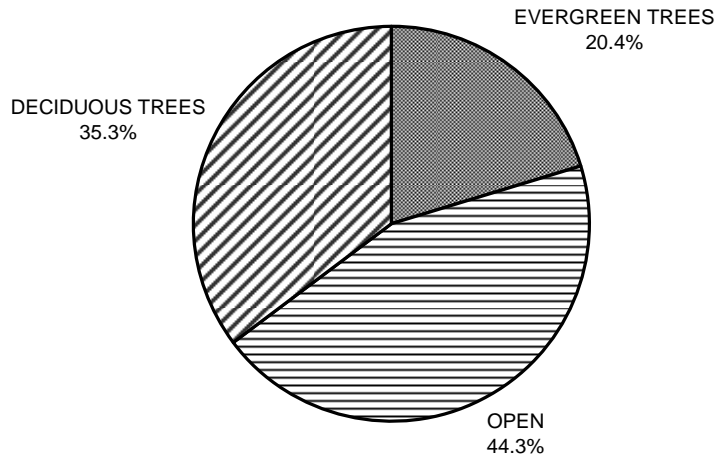
GRAPH 9. Mean percent canopy.

The mean percent canopy density for the stream reach surveyed was 56%. The mean percentages of deciduous and evergreen trees were 63% and 37%, respectively (Table 7). Graph 9 describes the canopy for the entire survey and Table 9 describes the canopy by reach.

The mean percent canopy for the survey was 54%. This is a low percentage of canopy, since 80 percent is generally considered desirable. The riparian buffer is thin or nearly absent in areas with livestock. Riparian removal from intensive grazing within the riparian corridor could lead to less stream canopy and channel incision causing bank erosion and higher water temperatures. Reach 1 had a mean canopy density of 19% with bank

- 3) Increase the canopy on Nolan Creek by planting willow, alder, redwood, and Douglas fir along the stream where shade canopy is not at acceptable levels (portions of Reach 1). The non-anadromous reach above the survey section should be assessed for planting and treated as well, since water temperatures throughout are affected from upstream. In many cases, planting will need to be coordinated to follow bank stabilization or upslope erosion control projects.

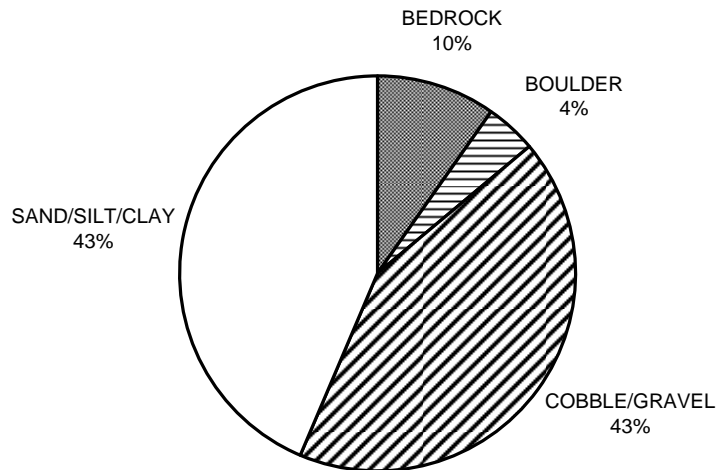
GRAPH 10. Dominant bank composition in survey reach.

For the entire stream reach surveyed, the mean percent right bank vegetated was 19% and the mean percent left bank vegetated was 14% (Table 7). For the habitat units measured, the dominant vegetation types for the stream banks were: 29% Deciduous Trees, 27% Grass, 22% Brush, 11% Bare Soil and 11% Evergreen Trees (Table 8 and Graph 11). The dominant substrate for the stream banks were: 43% Silt, Clay & Sand, 42% Cobble & Gravel, 10% Bedrock and 4% Boulder (Table 8 and Graph 10).
